WGSL, CQA Report Documenting Repairs to the Final Section of Cell E6 Liner  
Whelan, Joseph

Subject: Liner Damage Assessment, Repair, and Construction Quality Assurance Report  
for Cell E6 Sideslope, Waimanalo Gulch Sanitary Landfill, Kapolei, HI

**Figure 1  
MSW Cell E6 Sideslope  
Liner Damage Areas**

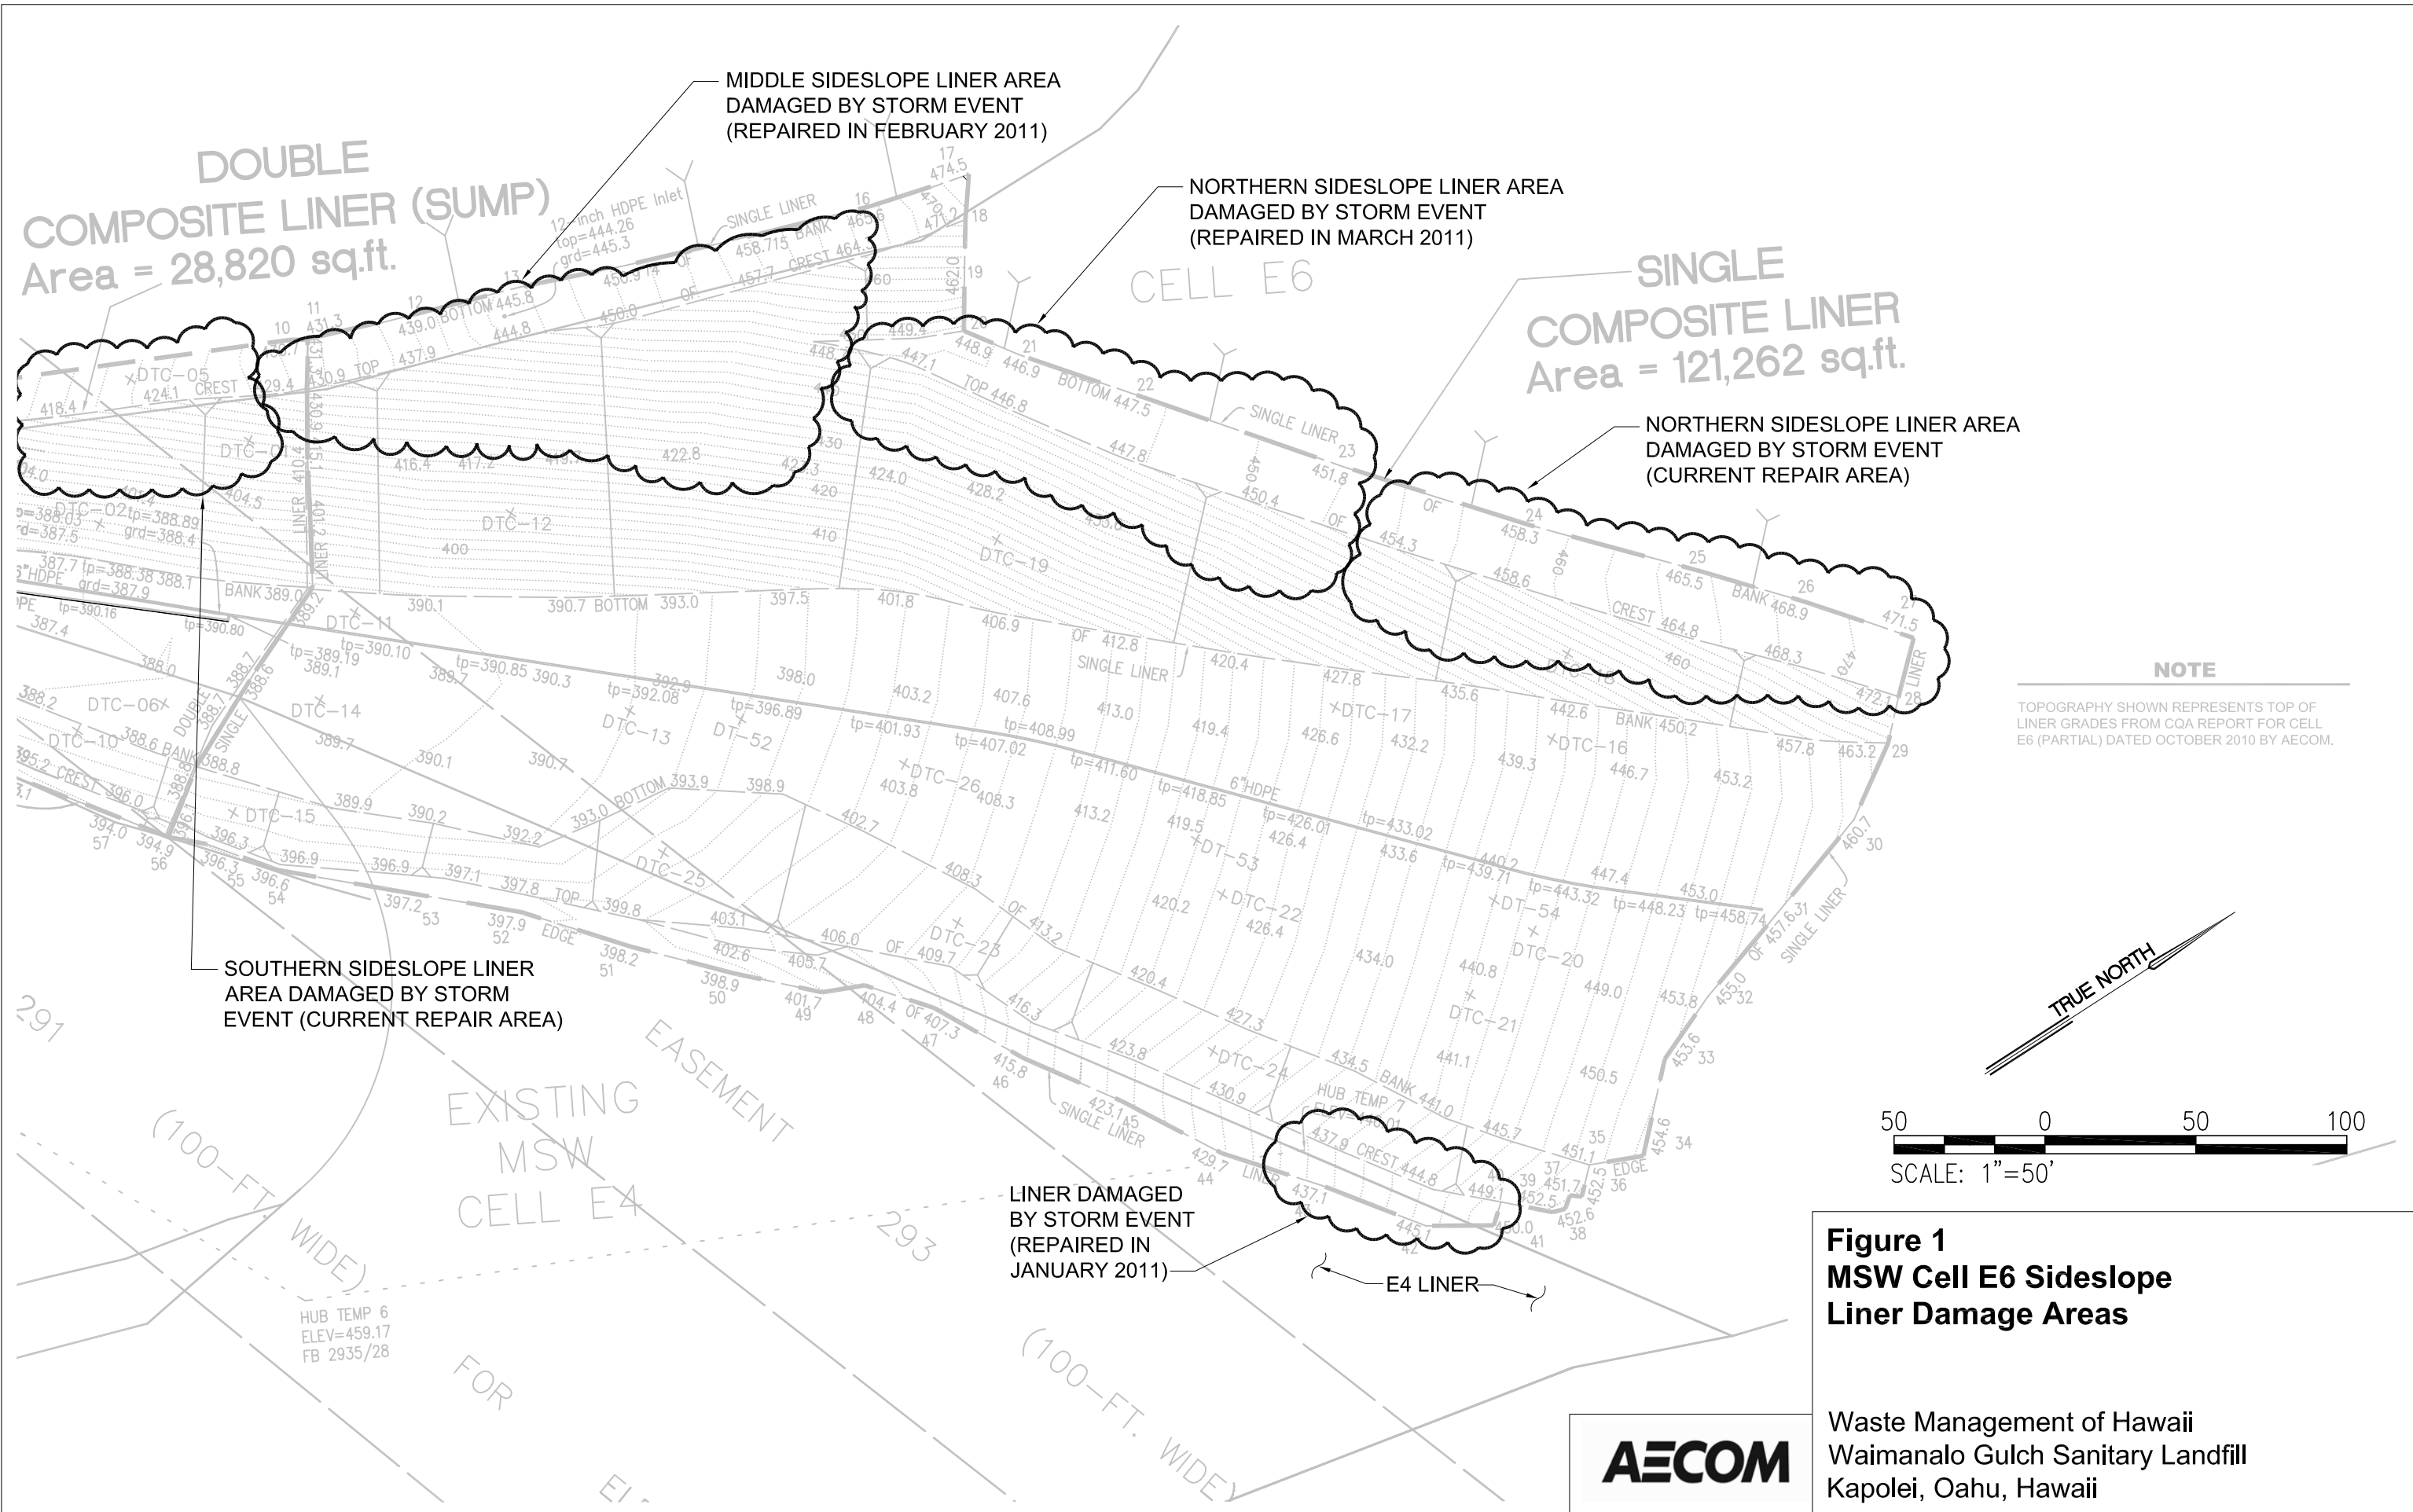
In late December 2010, a series of storms produced high run-on at the site resulting in damage to the northeastern edge of the MSW Cell E6 liner where it joins with Cell E4. Another large storm arrived on the evening of January 12, 2011 that resulted in additional flooding of the landfill and damaged the exposed portion of the western sideslope area of the MSW Cell E6 liner system. The damaged areas and repairs completed to date are shown on Figure 1, Attachment 1.

This letter report focuses on repairs to the northern half of the northern damaged area of the Cell E6 liner sideslope (see Figure 1), along the western edge of Cell E6. Repairs to the southern half of the northern sideslope area were documented in a previous letter report dated April 1, 2011. The activities described in this letter report complete the repairs to the Cell E6 liner that was damaged by the storm events. This Liner Damage Assessment, Repair, and Construction Quality Assurance Report follows requirements established in the *Workplan for Liner Evaluation and Repair* prepared by Geosyntec Consultants, Inc. dated January 27, 2011.

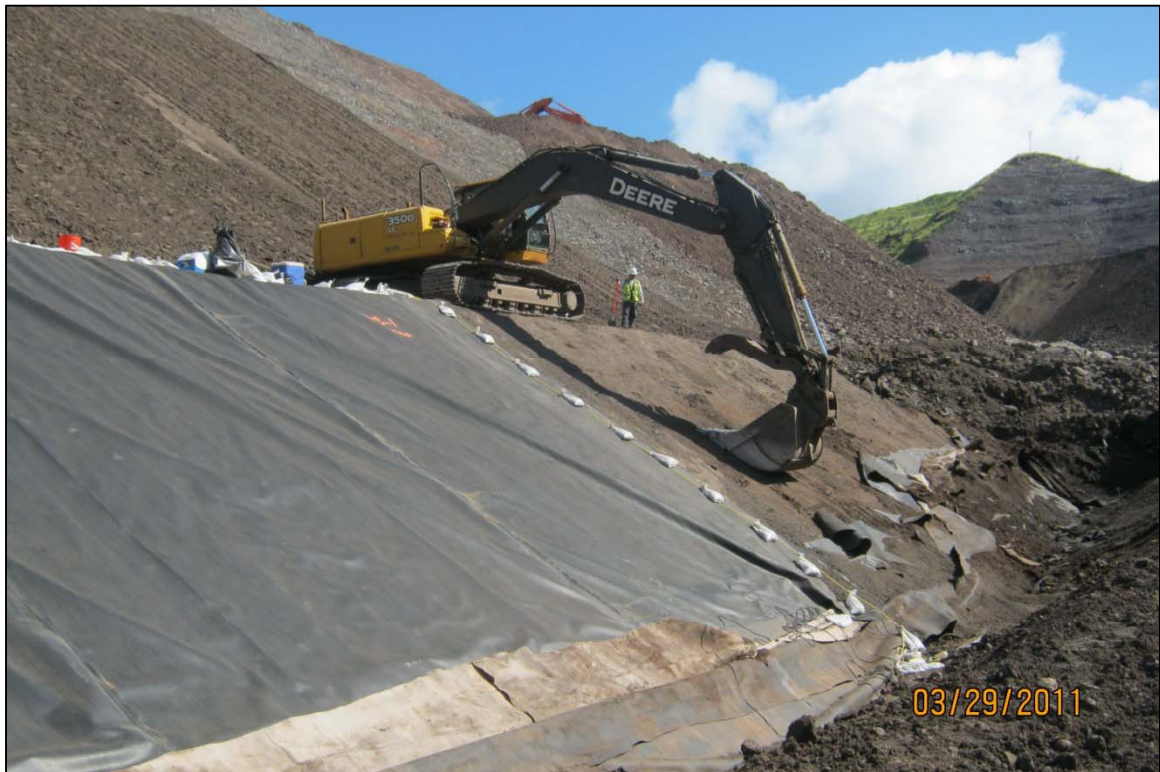
Photo 1: Excavator preparing subgrade of the northern portion of the northern repair area, looking north.

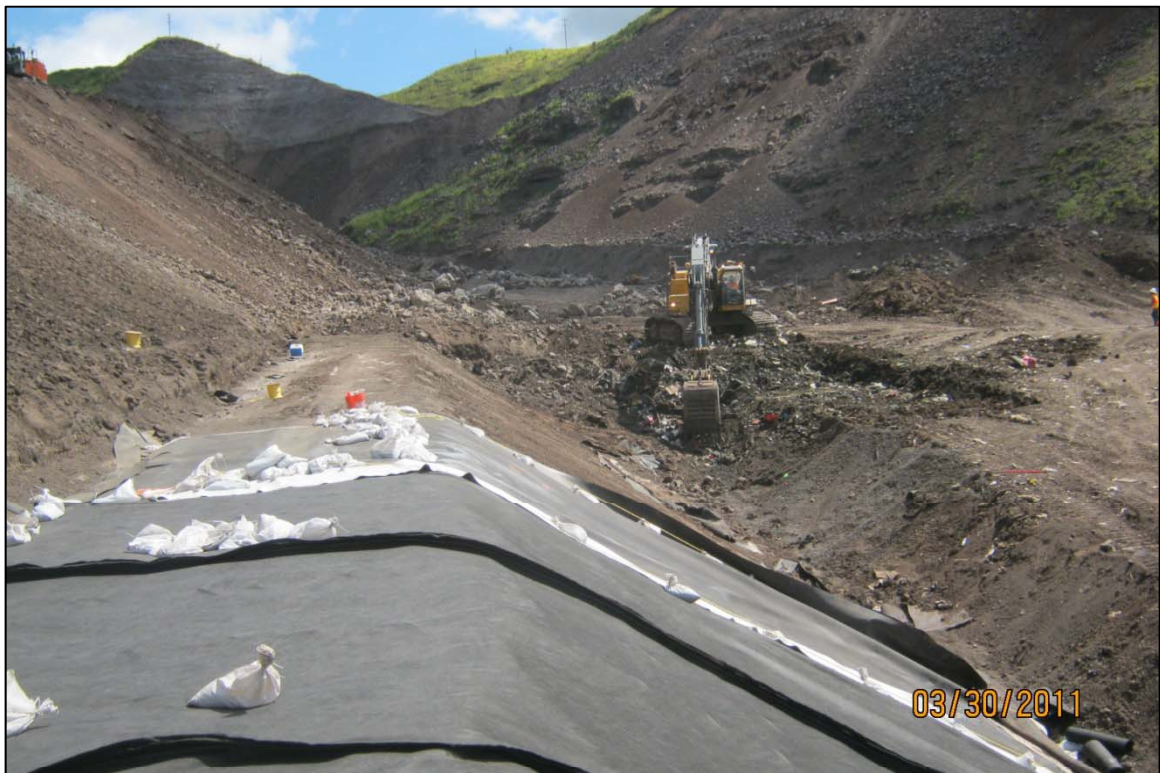
Photo 2: Excavating MSW to expose the northern portion of the northern repair area, looking north.

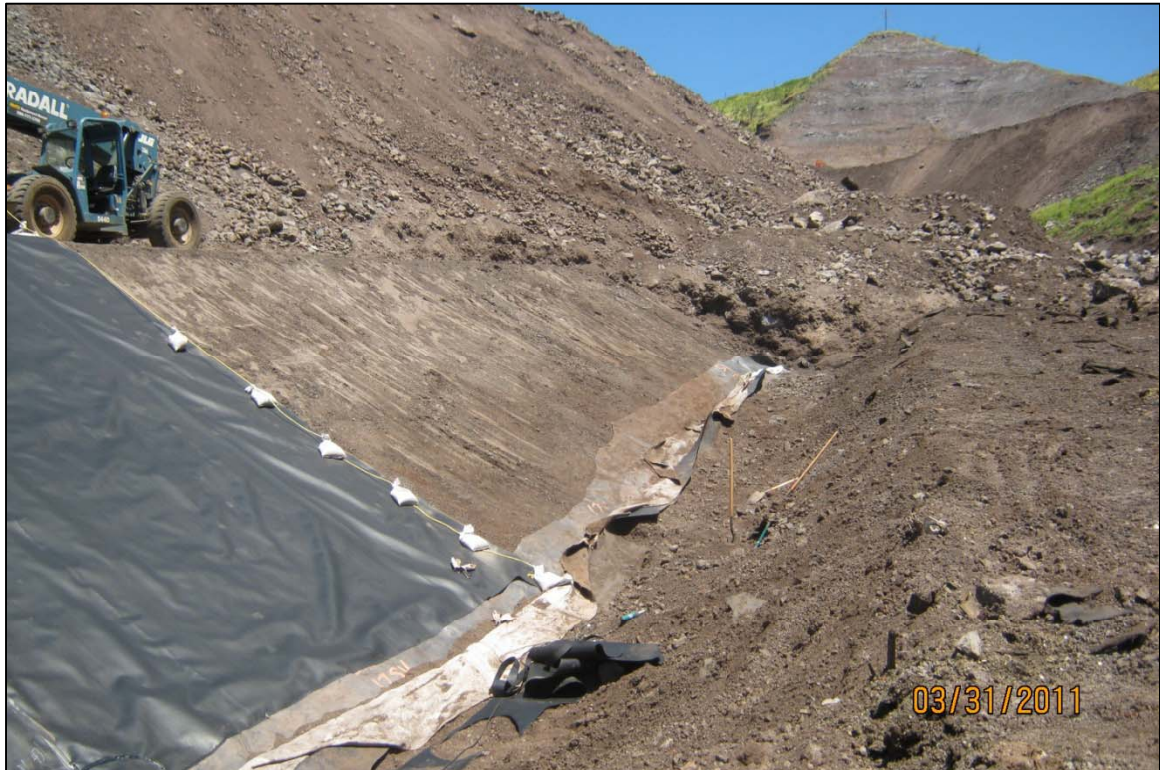
Photo 3: Northern portion of the northern repair area prior to deployment of 40-mil geomembrane.

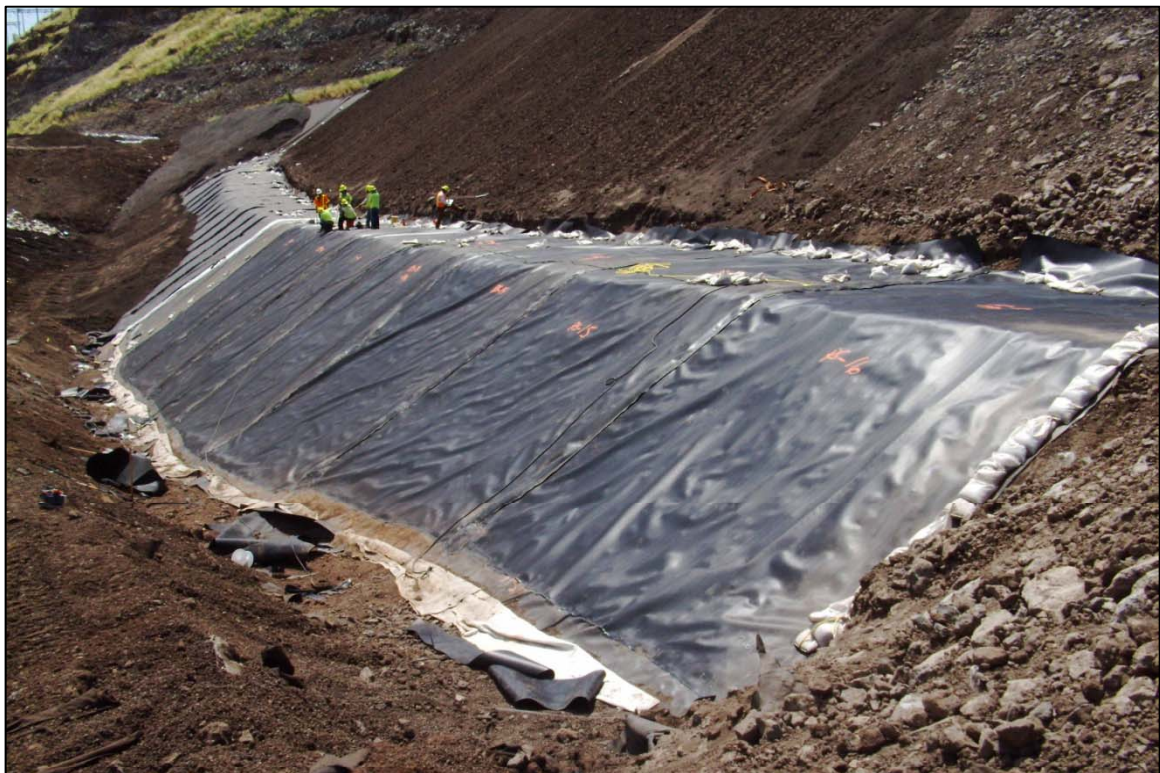
Photo 4: 40-mil geomembrane repair panels on the northern portion of the northern repair area, looking south.

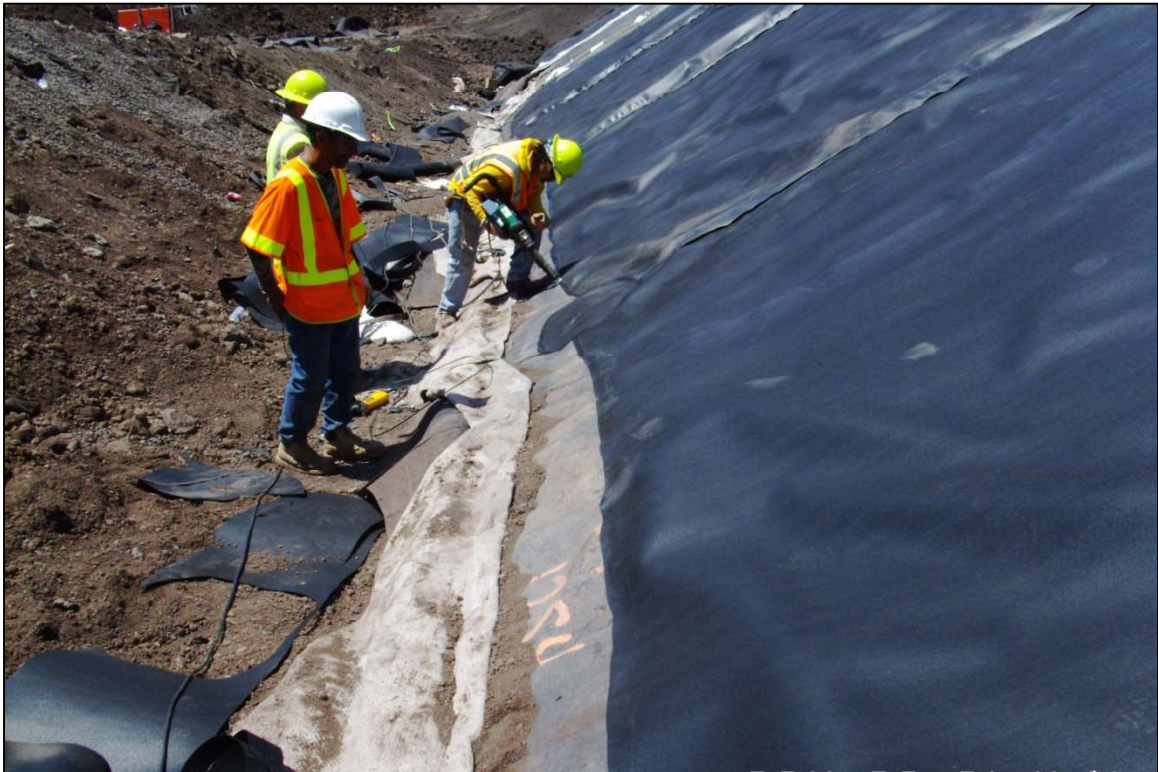
Photo 5: Extrusion welding the 40-mil geomembrane repair panel tie-in to the existing E6 liner system.

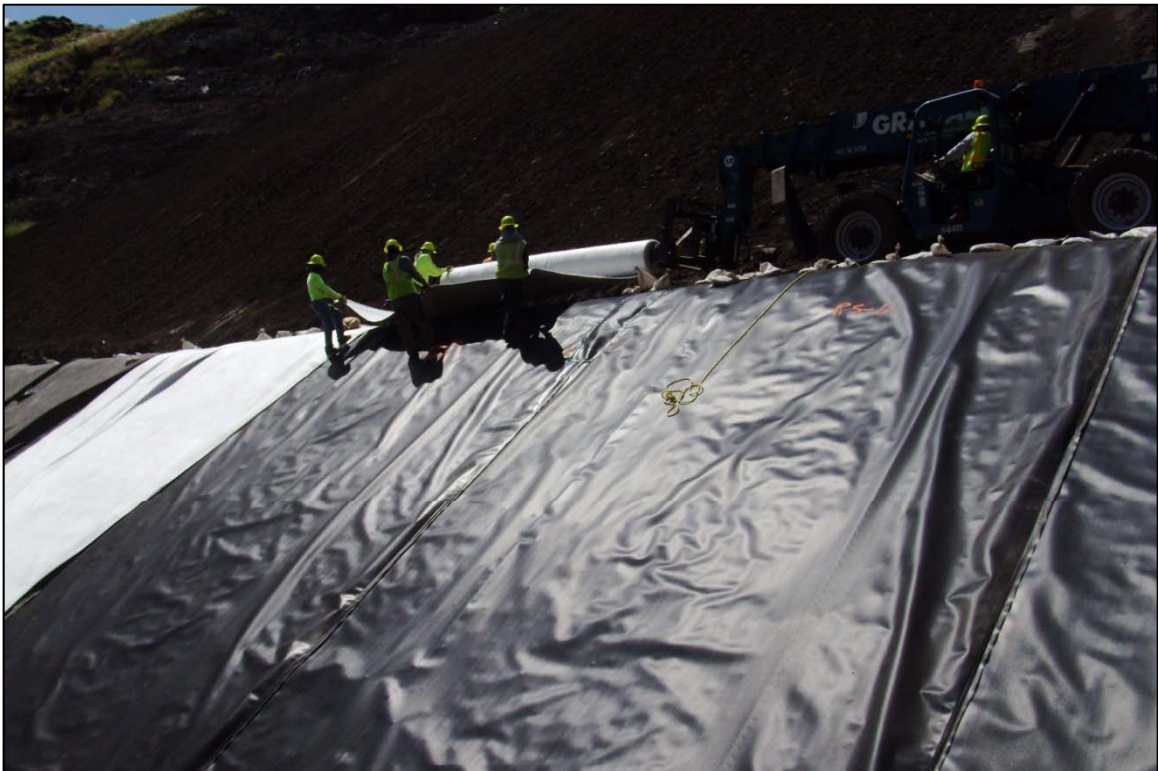
Photo 6: Deploying GCL over the 40-mil geomembrane repair panels on the northern portion of the northern repair area.

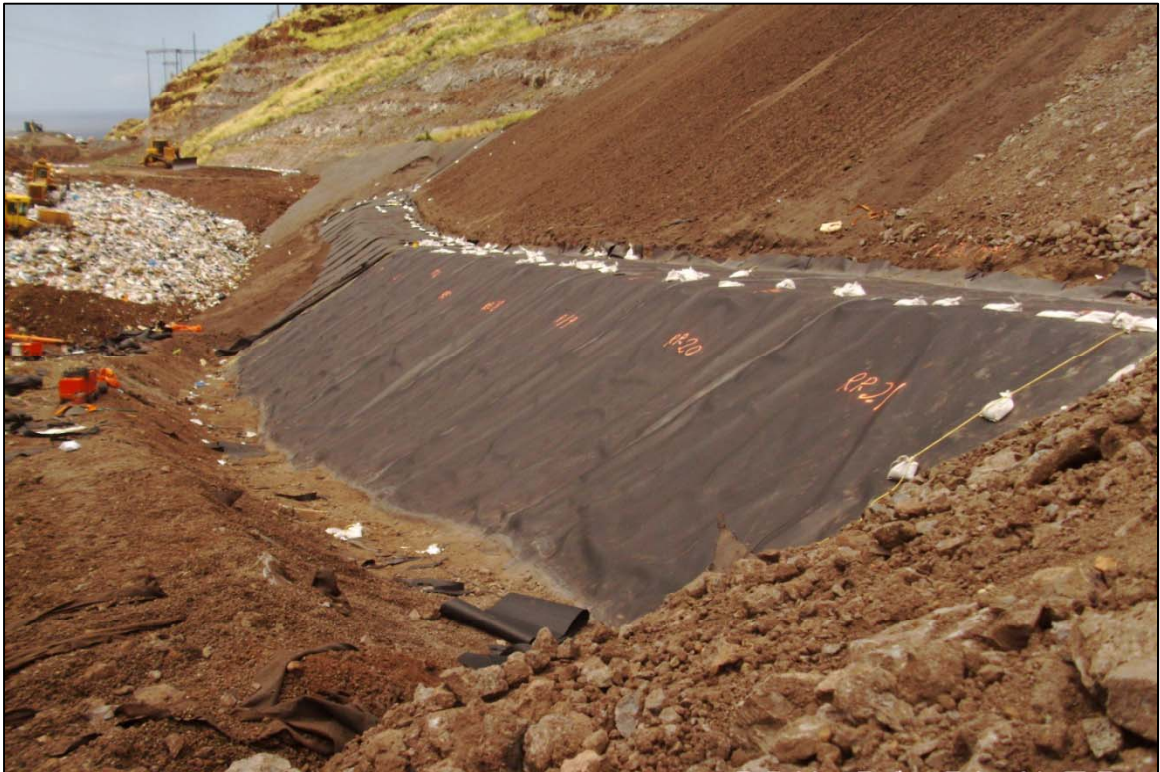
Photo 7: 60-mil geomembrane repair panels on the northern portion of the northern repair area, looking south. .

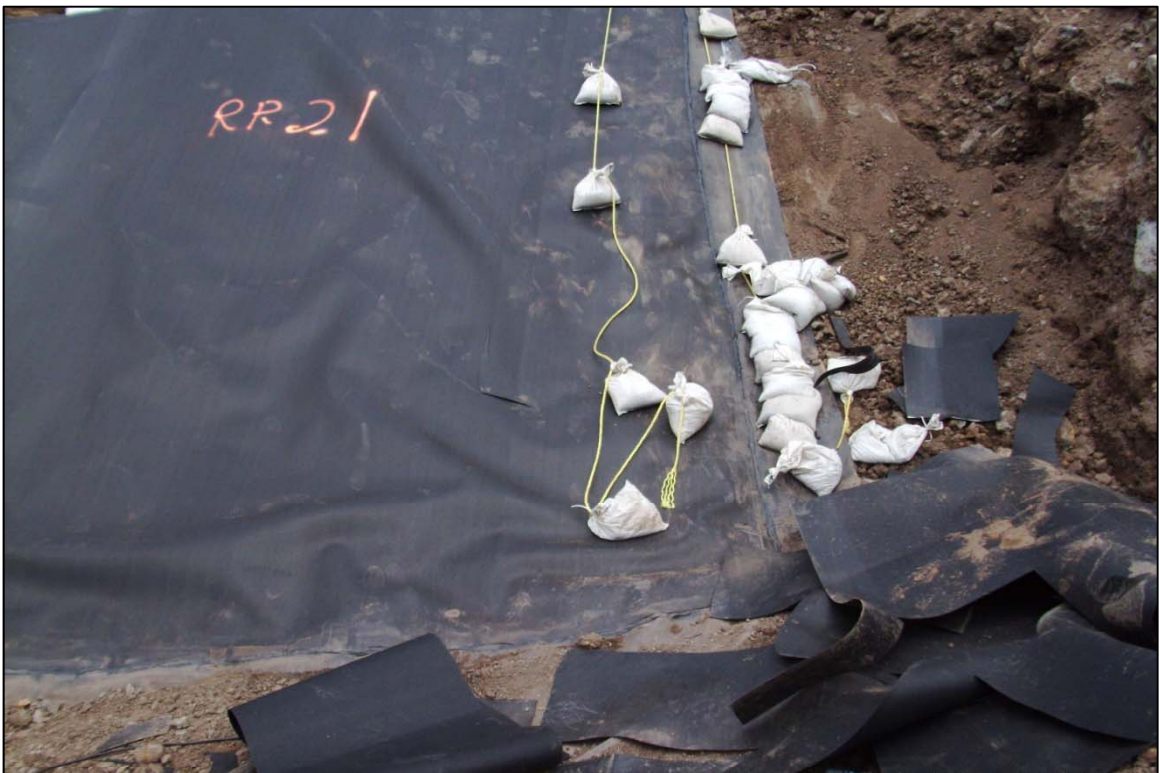
Photo 8: Encapsulated weld along the northern edge of the E6 liner system following installation of repair panels.

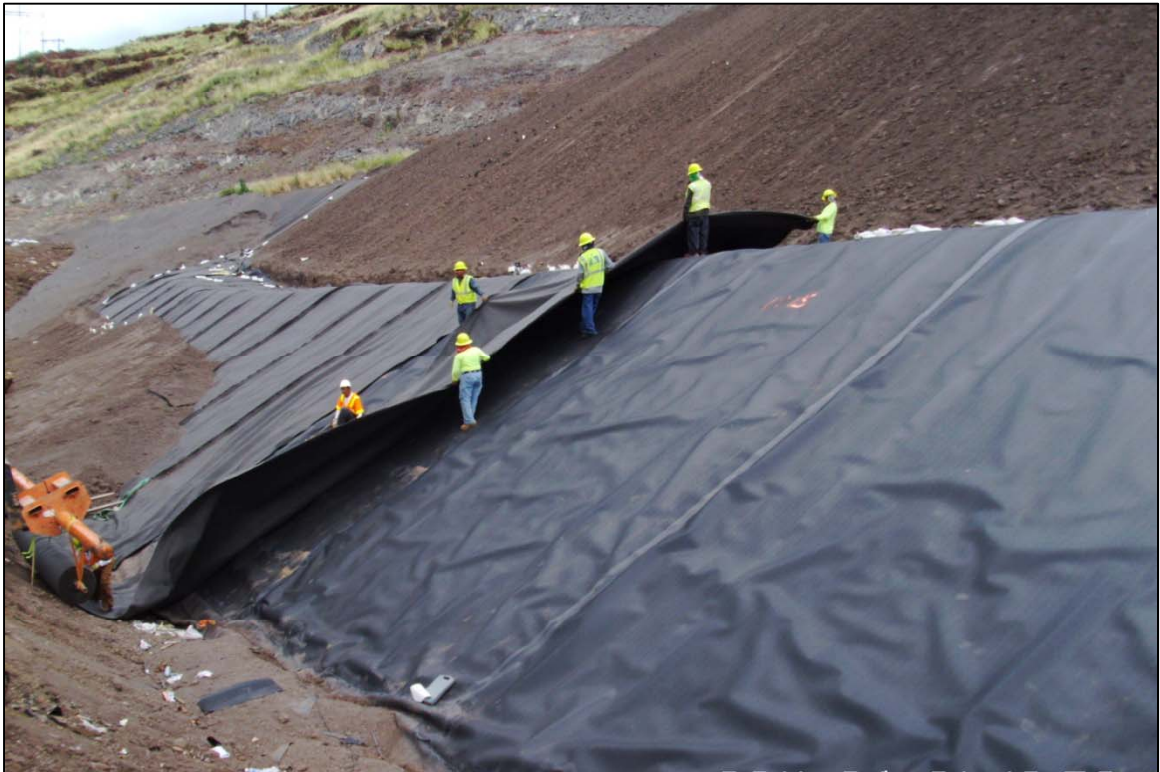
Photo 9: Deploying 16-oz geotextile over the repair panels on the northern portion of the northern repair area, looking southwest.

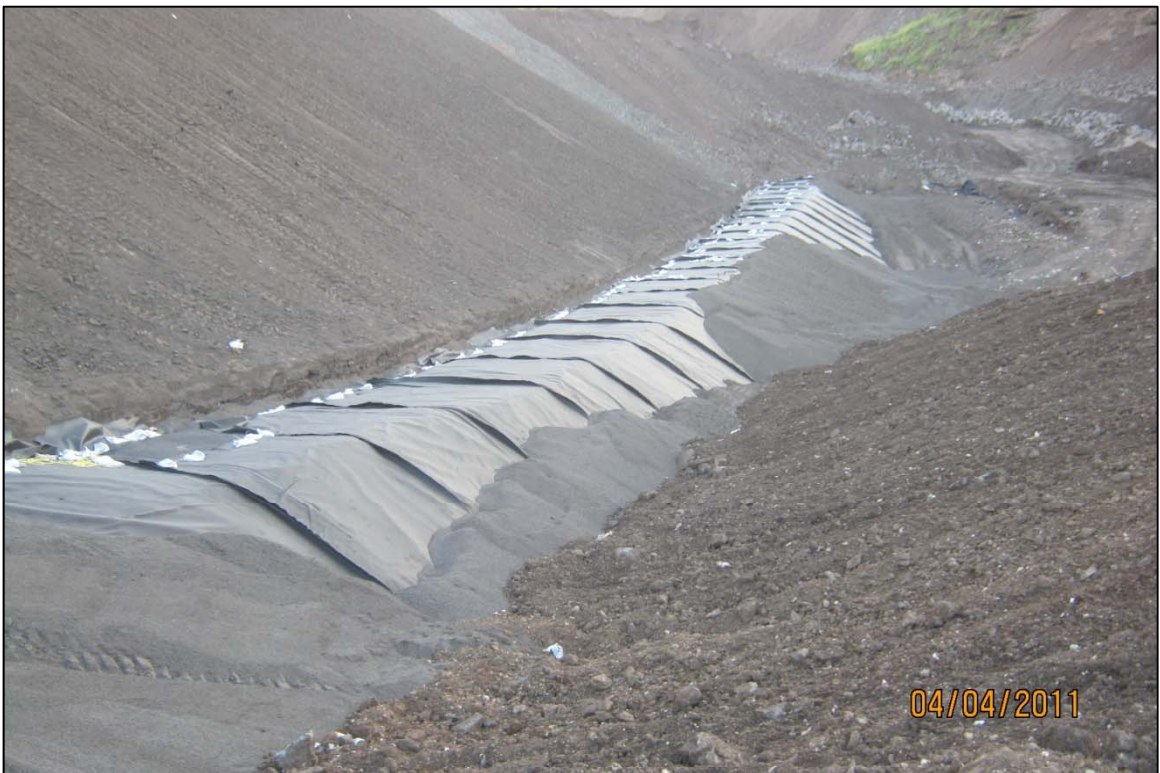
Photo 10: Operations layers on the northern portion of the northern repair area, looking north.
